TECHNICAL REPORT M-321
August 1982

COATINGS AND CATHODIC PROTECTION OF PILING
IN SEAWATER: RESULTS OF 10-YEAR EXPOSURE
AT LACOSTA ISLAND, FL

by
J. Bukowski
A. Kumar

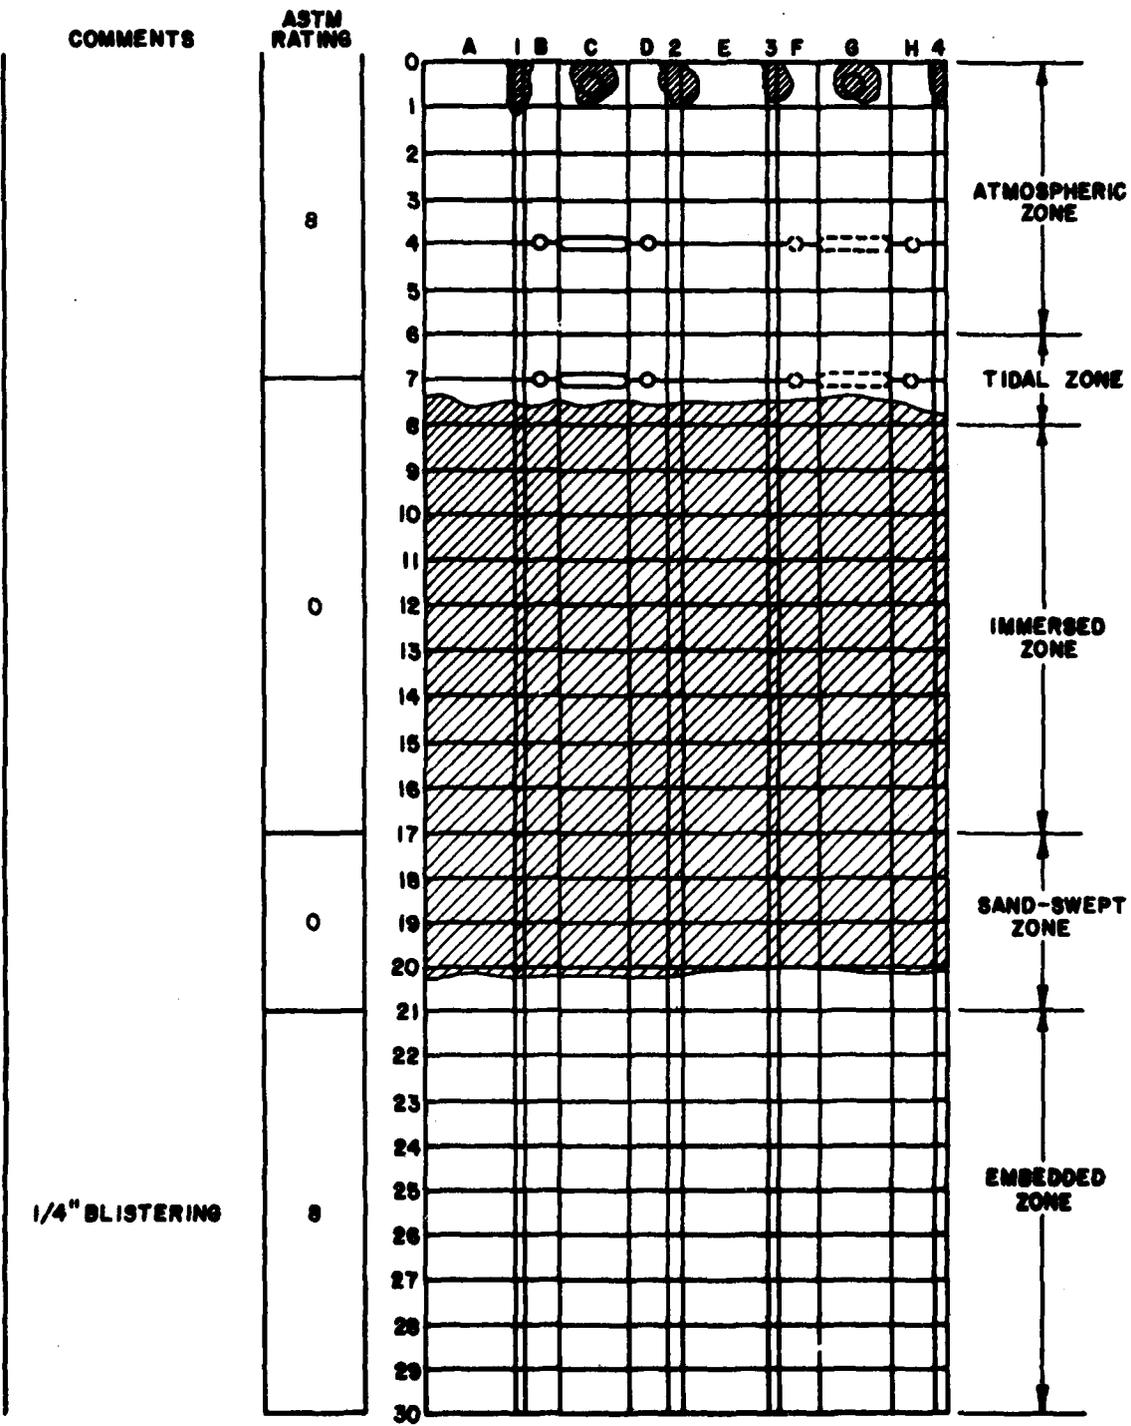
PILE NO. 21A

18. System 21 was an epoxy-tar over an inorganic zinc-rich primer. Some light rust was present along the flange edge in the atmospheric zone. There was complete loss of coating in the immersed zone, with severe rusting and pitting. The coating had blistered in the embedded zone.

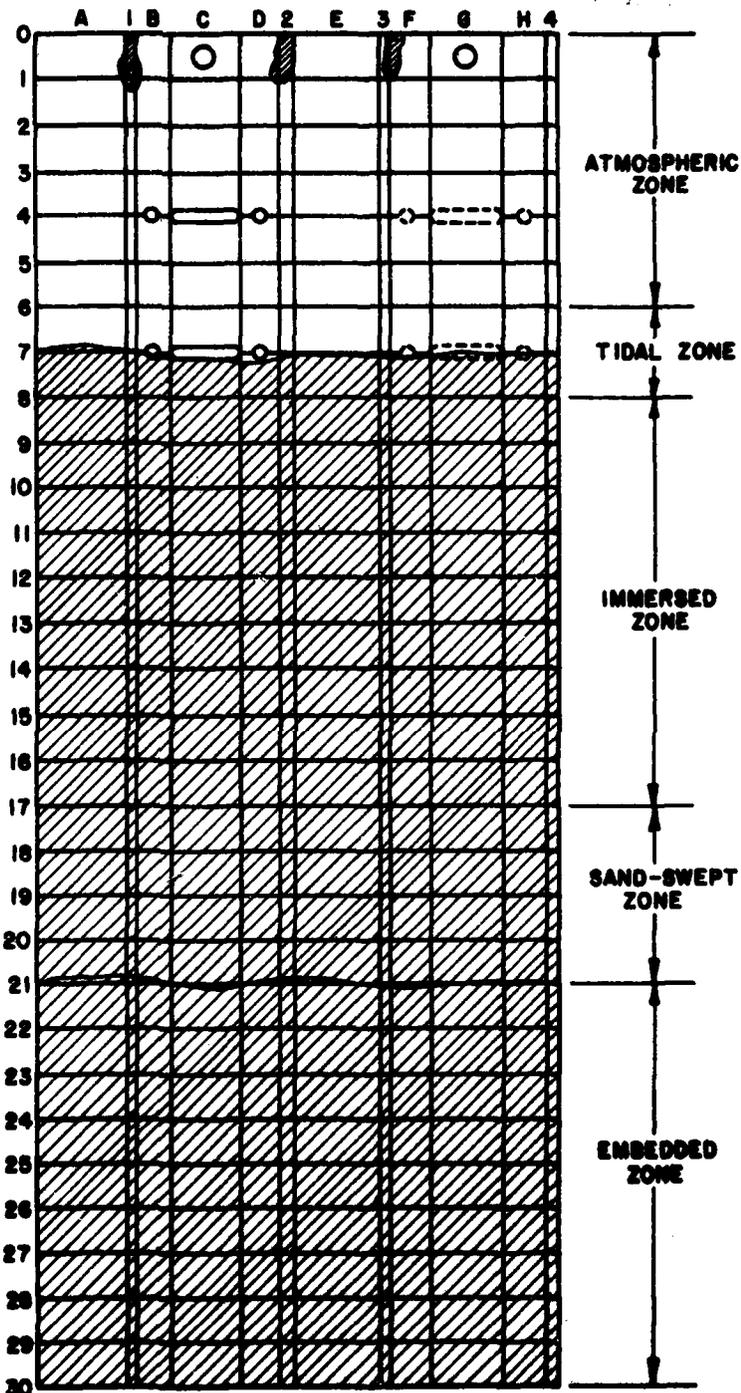
PILE NO. 22A

19. System 22 was a vinyl mastic topcoat over an inorganic zinc-rich primer. Light staining was present in atmospheric zone; complete loss of coating occurred in the immersed zone; dense blistering and rusting were present in the embedded zone.
